# **Mobile Pentium® II Processor Specification Update**

Release Date: March 1999

Order Number: 243887-008

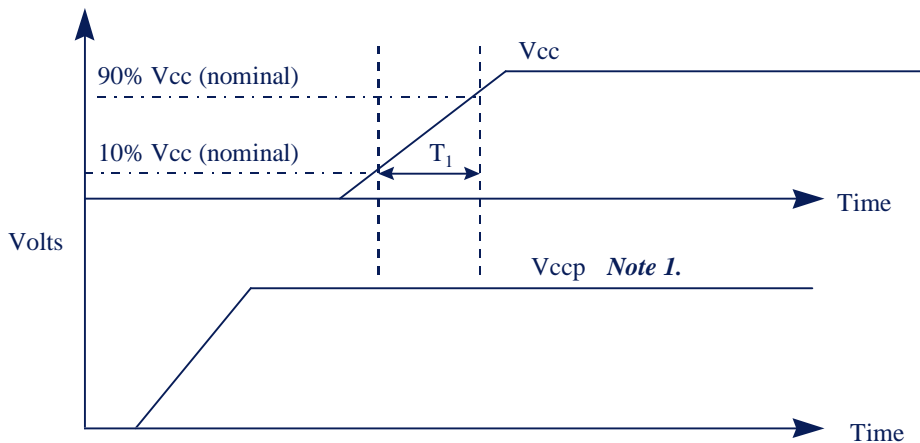
**Figure 1. V<sub>CC</sub>/V<sub>CCP</sub> Timing Requirements (Mobile)**

**PROBLEM:** The processor uses the PWRGOOD signal to ensure that no voltage sequencing issues arise; no pin assertions should cause the processor to change its behavior until this signal is asserted, when all power supplies and clocks to the processor are valid and stable. However, if  $V_{CC}$  ramps up before  $V_{CCP}$ , it will cause the processor to enter an invalid state.

**IMPLICATION:** If this erratum occurs, the system may boot normally however, the L2 cache may not be initialized.

**WORKAROUND:** For Mobile Pentium II processors, ensure that  $V_{CC}$  ramps after or with the L2 cache IO voltage ( $V_{CCP}$ ). If  $V_{CCP}$  ramps after the  $V_{CC}$ , a delay circuit can be placed on the core  $V_{CC}$  to ensure that  $V_{CC}$  ramps at the same time or after  $V_{CCP}$  as shown below in Figure 1.

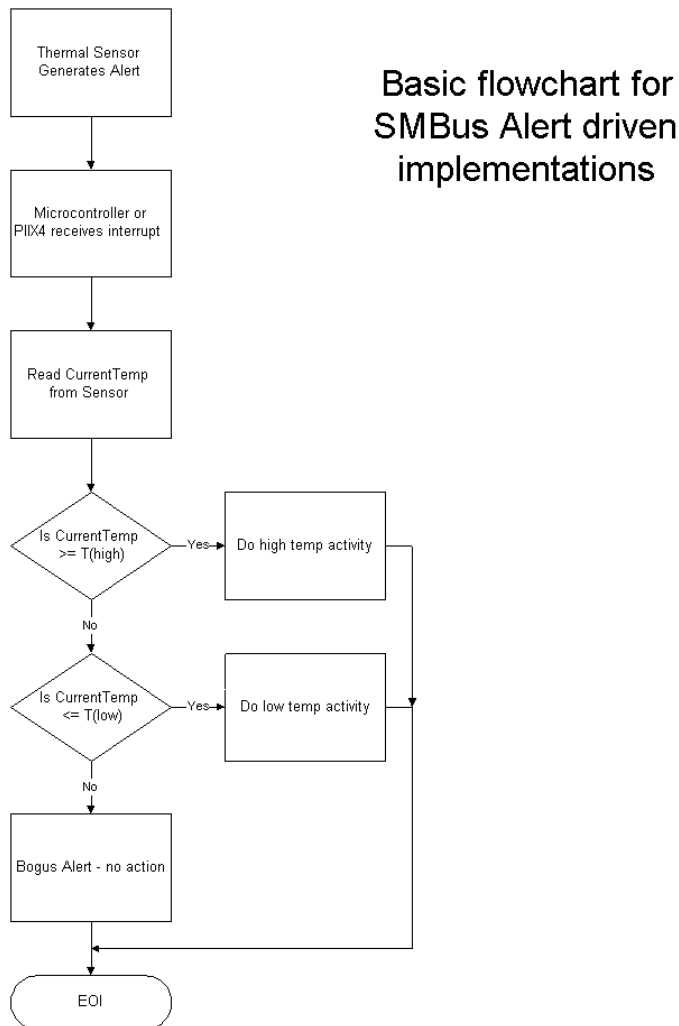
Figure 2. Workaround Flowchart: SMBALERT#-Driven System

Under the conditions described below, the thermal sensor incorrectly generates the SMBALERT# interrupt. *All* of the following conditions must be met to trigger a false interrupt:

1. Before servicing an interrupt from the thermal sensor, read and compare the processor thermal reading with the threshold limits ( $T_{HIGH}$  or  $T_{LOW}$ ). Figures 2 and 3 provide basic flowcharts for the implementation of this workaround in an interrupt driven system.
2. If the firmware implemented polls the Status Register only, then before taking any action, re-read the temperature register and do a comparison with the alarm threshold limits ( $T_{HIGH}$  or  $T_{LOW}$ ) to determine if the value is actually still within the temperature window.
3. Use a temperature polling scheme to monitor the processor temperature.
